An Optimized Heat Treatment for Bearing Cup Using FEA Analysis

D.R.Lahore¹, R.A.Kathar²

*1 PG Student Jawaharlal Nehru Engineering College,
N-6 Cidco, Aurangabad, Maharashtra, India
dhanshri.lahore@gmail.com*

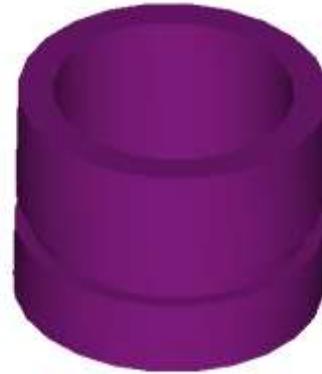
Fig-5.1 Pro-E Model of Bearing Cup

The 3-D model of cup was modelled in Pro/ENGINEER software as shown in fig5.1 and then imported in HyperMesh software.
